Technical Note: Cubbington Wild Pear Tree

Document no.: C253-ATK-EV-NOT-030-0000035

Revision	Author	Date	Issued for/Revision details
P02	Tom Dale/Kat Stanhope	21.10.15	For Issue

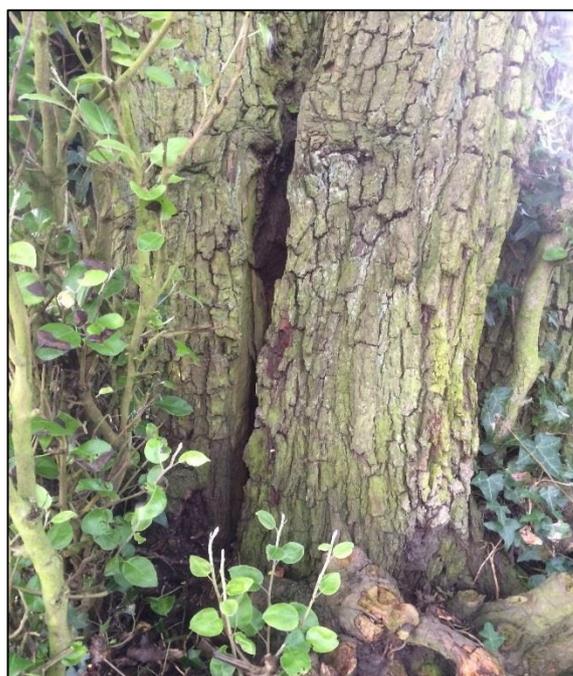
- 3.3.1 The tree is growing with a slight lean to the south. There is an elongated cavity 100mm wide between the north and east stems extending down the trees trunk to ground level (see Figure 1). This split is likely to be a result of a previous included bark junction where the union contained a region of bark-to-bark contact between the two stems. The internal structure of such a union usually allows them to be pulled apart more easily than a normal branch union from a main stem.

Figure 1 - Elongated cavity extending down main stem at union between north and east stems

- 3.3.2 This elongated cavity is likely to have been produced due a previous co-dominant union being pulled apart, as this type of branch union has no resistance to tensile stress (pulling) (Lonsdale, 1999). At present it is considered that this cavity has not yet induced a significant full or partial failure of the tree as the crown structure above the wound is currently supporting each other and reducing the wind sway potential of the north and west stems. This seemingly has reduced the wind load stresses being passed down into the trunk that could

initiate such a failure. The cavity is old as noted by the grey/green colour; a fresh wound would be green/white.

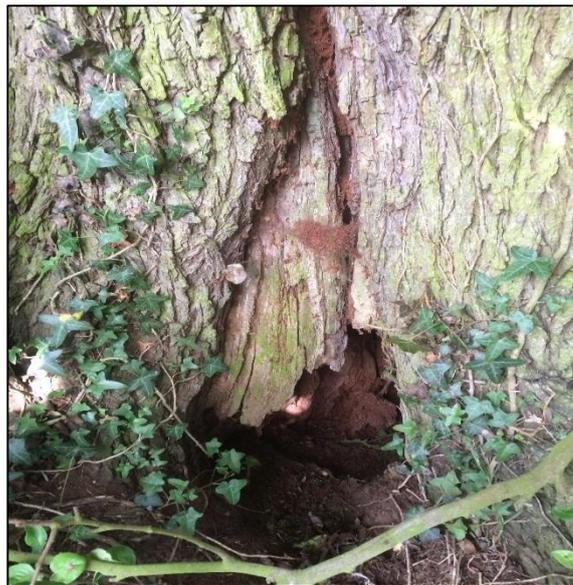
- 3.3.3 There is a cavity on the south side of trunk from ground level to 1.3m (see Figure 2). This cavity revealed that the entire internal circumference of the trunk of the tree is hollow; the void was measured to be 650mm diameter. The rot present being typical of brown rot with a brittle framework of decaying wood and brown dust present. Surprisingly, no wood decay fungi were observed within this area or at any point on the tree.

Figure 2 - Elongated cavity to 1.3m height above ground level on the south east side of the trunk

- 3.3.4 The speed at which the internal decay has progressed is not quantifiable by this assessment. However, using the t/R ratio formulated by Mattheck and Breloer (1994) it would appear the remaining un-decayed wood that is supporting the tree equates to approximately 44% of the trunk's radius, or approximately 264mm in thickness. The significance of this remaining sound wood or 'critical wall' is that a hollow stem with a wall below 30% is much more likely to fail as a result of a buckling or flattening of the cross-section very much like a hose-pipe when it is pushed together (Mattheck & Breloer, 1994).

- 3.3.5 When analysing this figure one must note that the formula does not take into account other tree defects, such as open cavities that can contribute to a loss in wood strength. The formula is based on a complete cylinder, so the presence of cavities in the trunk also needs consideration as these account for approximately 10% of the stem circumference. Therefore, using Table 4-2 from the F.A. Bartlett Tree Expert Co.'s 'Tree Risk Management Manual' (2007) this tree still sustains over the minimum thickness of sound wood required for a tree not to be considered at high risk of failure, i.e. over 200mm.
